Tijuana River Bacterial Source Identification Study

Final Report

**City of Imperial Beach
Public Works Department
495 10th Street
Imperial Beach
CA 91932**

Weston Solutions, Inc.
5817 Dryden Place, Suite 101
Carlsbad, California 92008

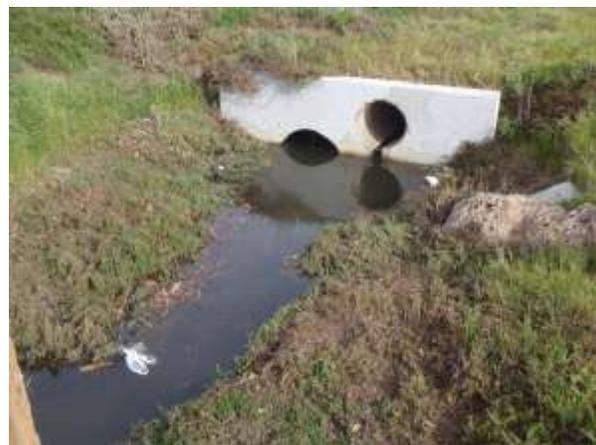
E-line storm drain outfalls showing minimal dry weather flow directly to the Tijuana River Estuary. The majority of dry weather flow from other sub-drainages on the U.S. side of the border never reaches the estuary.

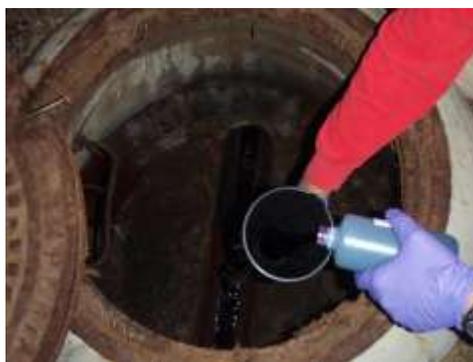
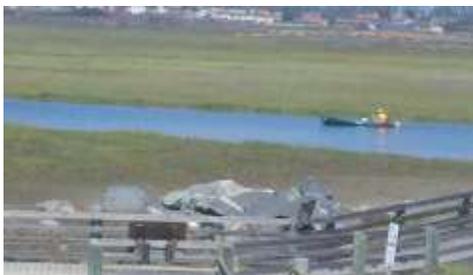
Seacoast Drive Special Study showing insertion of rhodamine dye and collection of dye and bacterial samples in the Tijuana River Estuary adjacent to Seacoast Drive. Evidence of bacteria from human origin was not observed in the estuary after the Seacoast Drive pump station was sealed by the City of Imperial Beach.

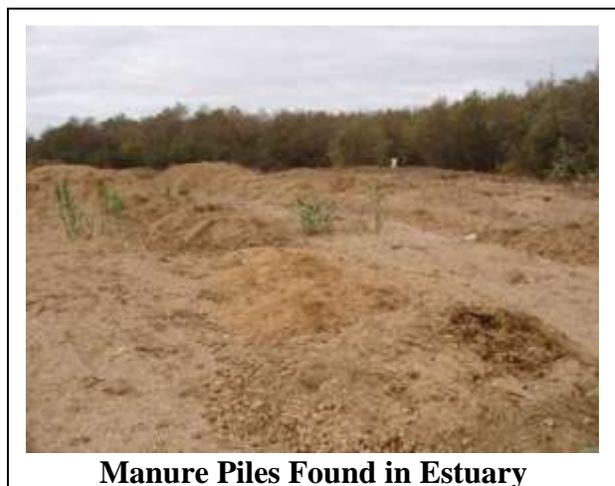
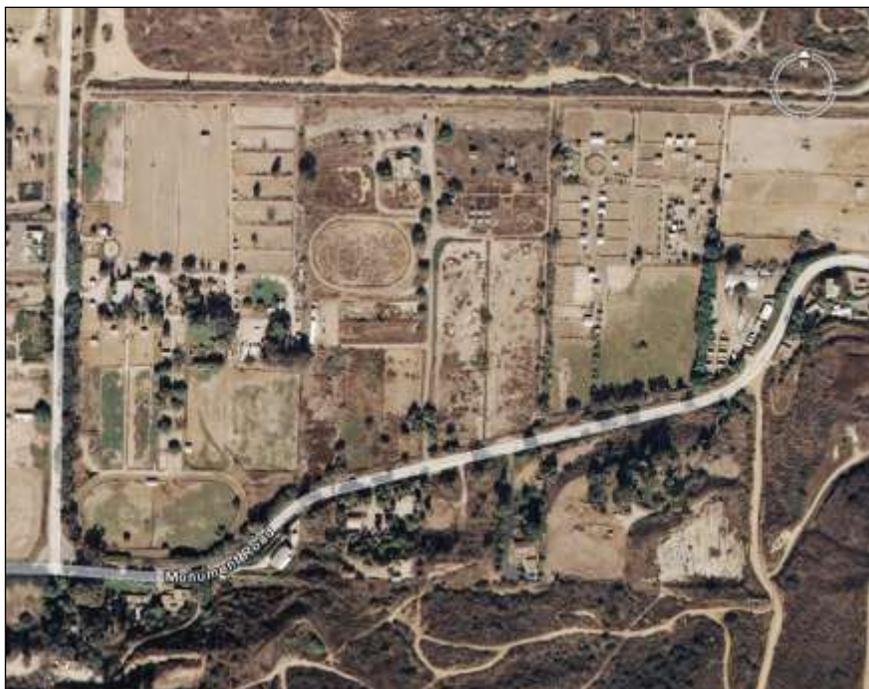
Figure 2-6. Example of Ranches in Tijuana River Valley¹

Several ranches growing intensive row crops are located on the U.S. side of the border (Figure 2-6). Approximately 57 acres of crops are grown along the northern boundary of the Tijuana River Valley near Hollister Street Bridge at the base of Spooner's Mesa north of Monument Road and just south of the Tijuana River on the eastern side (Weston, 2007). In addition to these agricultural land uses, there are both private and commercial horse ranches which provide breeding and trail riding services to the region. Regulation and oversight of the discharges from these facilities is intermittent. There is anecdotal evidence of manure dumping in the Tijuana riverbed to the west of Saturn Blvd. This has been identified and brought to the attention of the SDRWQCB where investigations are ongoing (Keir–City of Imperial Beach pers. comm. 2008).

Manure Piles Found in Estuary

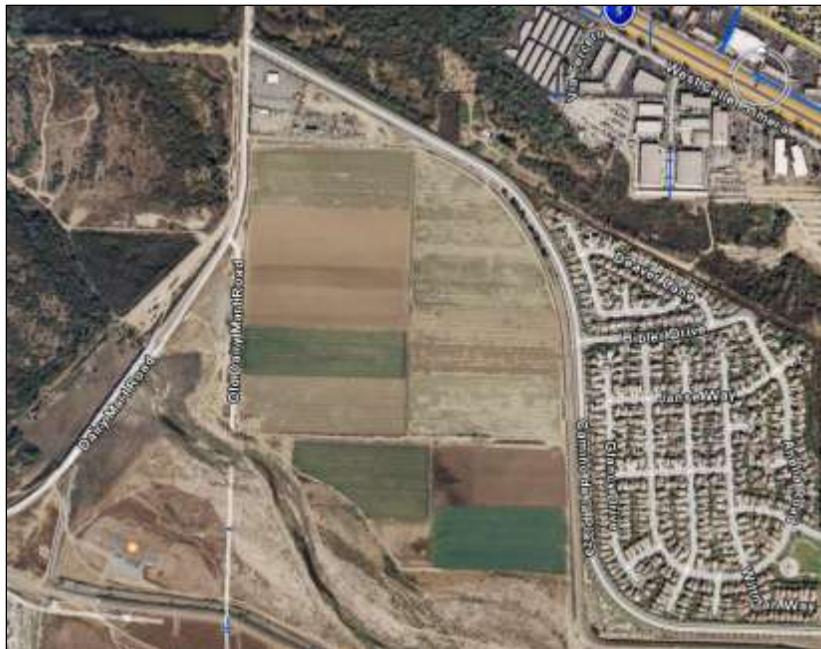
Figure 2-7. Sod Farms Leased from IBWC1

The USIBWC leases land to commercial groups adjacent to the Tijuana River. In order to retain the lease, only low-growing row crops, such as sod, lima beans, and strawberries, are farmed (Figure 2-7). Water is pumped from groundwater wells adjacent to the Tijuana River and used to irrigate the land. Any irrigation runoff flows back into the Tijuana River (Melvin–USIBWC pers. comm. 2008).

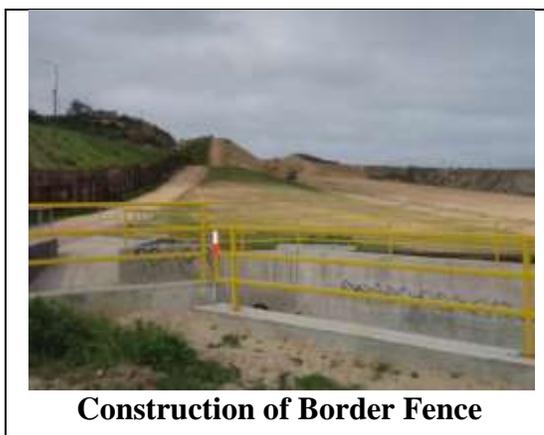
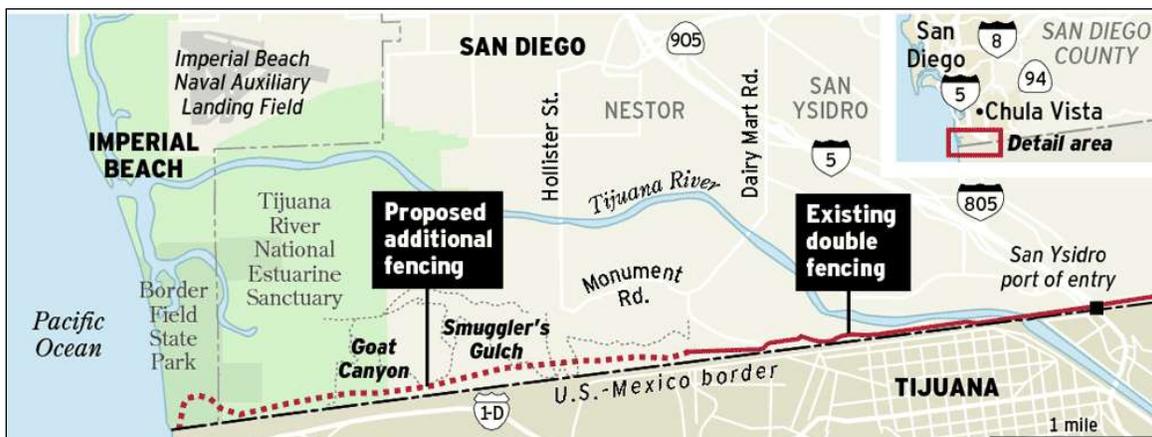
Figure 2-13. Border Fence Construction⁸

The diversion system currently in place at Smuggler’s Gulch and Goat Canyon is being completely restructured due to the construction of the extended border fence. The U.S. Customs and Border Protection agency is the responsible party for the construction efforts. The project will consist of constructing an earthen berm across Smuggler’s Gulch canyon to support a 3.5-mile long, 15-foot secondary steel-mesh fence as well as all-weather patrol and access roads (Figure 2-13). Diversion structures at these sites have not yet been finalized, and therefore, the impact of changed flows from these sites is still not known. It is envisioned that the reconfigured diversions will be significantly more robust than those currently present at the sites (Smullen–USIBWC pers. comm. 2008).

Construction of Border Fence

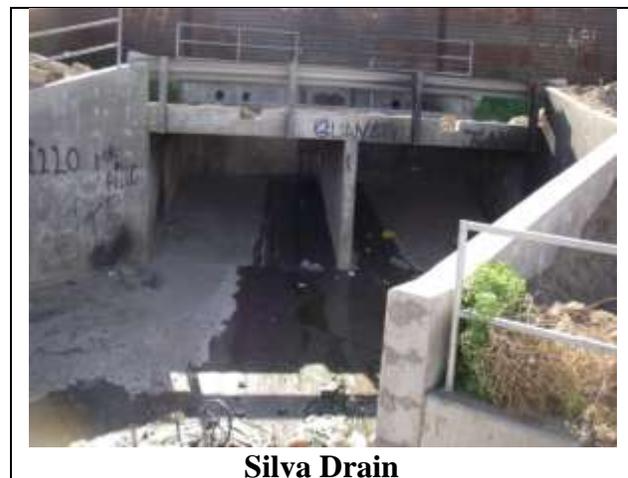
The Silva Drain is relatively small compared to Goat and Smuggler’s Gulch but still can contribute significant runoff because of the highly urbanized land use in the Mexican drainage area. Periodic Tijuana sewer infrastructure failures allow raw sewage to flow through this drainage.

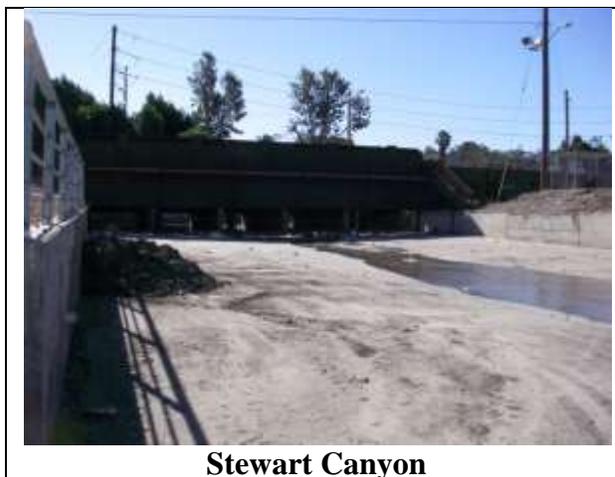
The Stewart Canyon drainage is also one of the smaller canyons crossing the border. The canyon drains land from a highly urbanized section of Tijuana which has been identified as having poor wastewater infrastructure. Periodic Tijuana sewer infrastructure failures allow raw sewage to flow through this drainage.

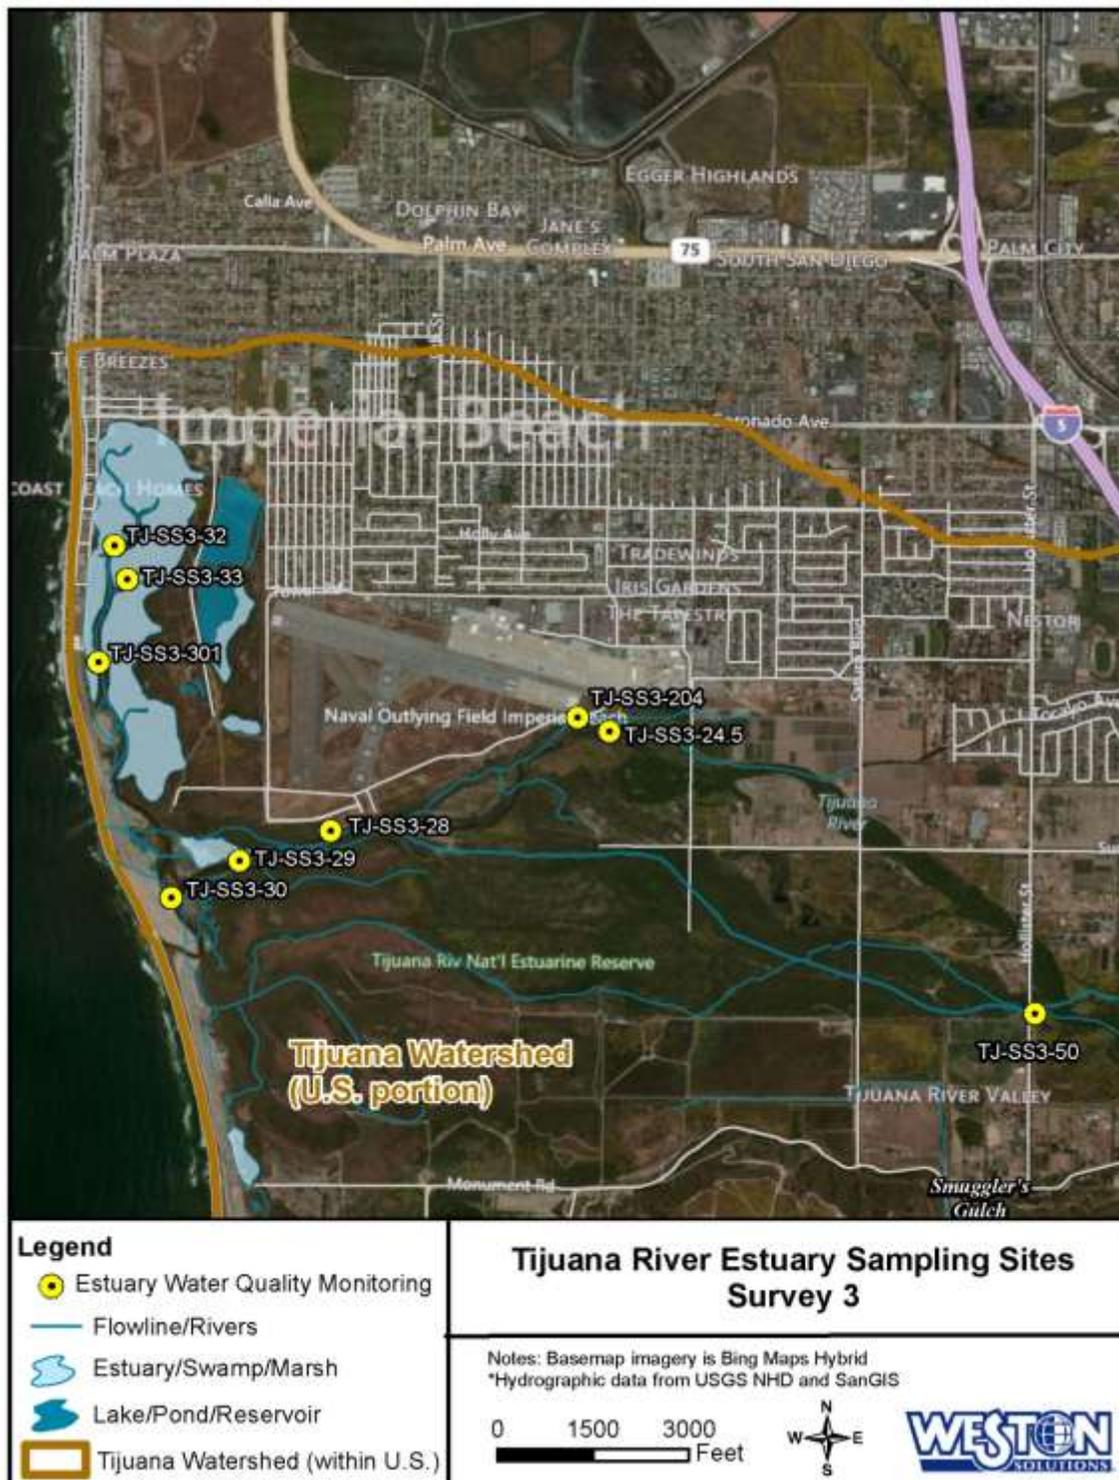
Figure 4-5. Sanitary Survey 3 Sample Locations in the Tijuana River Estuary

On September 2, 2011 eight sites were sampled within the Tijuana River Estuary as part of Sanitary Survey 3 (Table 4-7, Figure 4-5). Samples were collected at each of the eight sites every two hours across the tidal cycle for a total of five to six samples per site. (Table 4-7, Figure 4-5). Two additional samples were collected at the mouth of the Tijuana River Estuary. The objective of this study was to determine if the estuary contained high concentrations of indicator bacteria and if those concentrations changed over the course of a tidal cycle. Additional samples were collected from several sites within the watershed, but no flow was observed at any of the sites visited. Pounded water was collected from those sites where it was present. The complete report for this assessment is provided in Appendix D.

Analytical results for all of the estuary sites are presented in Appendix D and summarized here. Water quality parameters (*e.g.*, DO, turbidity), bacteriological indicators, and *Bacteroides* were collected at each of the sites; however, nutrients (*e.g.*, nitrate) and ammonia samples were only collected at four of the sites. All of the samples collected in the Tijuana River Estuary had water quality parameters, ammonia, and nutrient values below their respective WQ benchmarks. Results for both fecal coliform and *Enterococcus* in each of the samples were also below their respective WQ benchmarks. All of the samples indicated the presence of general *Bacteroides* except one sample collected at TJ-SS3-32 and one sample at TJ-SS3-301. None of the samples were positive for human-specific *Bacteroides*.

All of the sites were negative for human-specific *Bacteroides* during each sample round. Indicator bacteria concentrations were also below threshold concentrations at all sites during each sampling round. Most sites had indicator bacteria concentrations at or near the minimum detection limit throughout the tidal cycle.

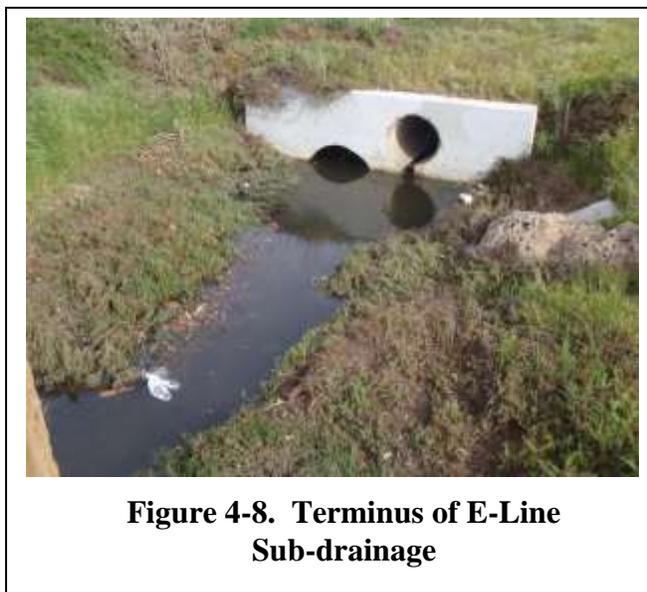
- Ponded water was found at all three sites at the time of the survey.
- Bacterial concentrations did not exceed thresholds at any sites.
- Human-specific *Bacteroides* was not present at any site.
- Minimal flow was observed draining directly to the Tijuana River Estuary (Figure 4-8).

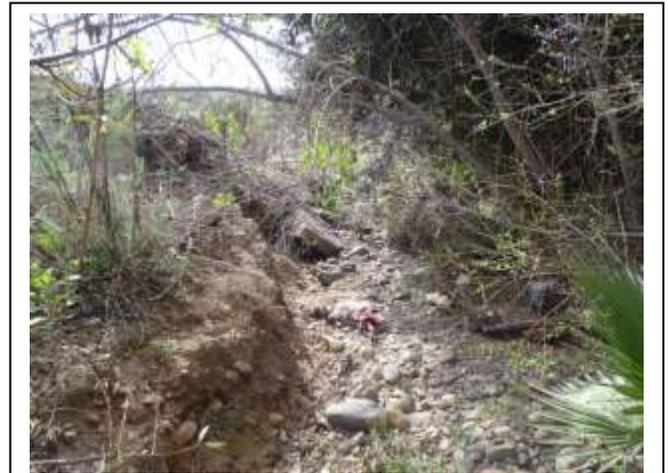
Figure 4-10. Terminus of Cochabamba Sub-drainage

- Ponded or dry conditions were found at all sites at the time of the surveys, except one site where minimal flow was observed.
- Bacterial concentrations exceeded thresholds at three of the monitoring sites.
- Human-specific *Bacteroides* was not present at any site.
- The Cochabamba Sub-drainage discharges to a sandy, soft-bottom depression in the flood plain of the Tijuana River Estuary (Figure 4-10). Based on these dry weather investigations and numerous site visits it is apparent that runoff in the Cochabamba Sub-drainage does not reach the estuary during dry weather conditions.

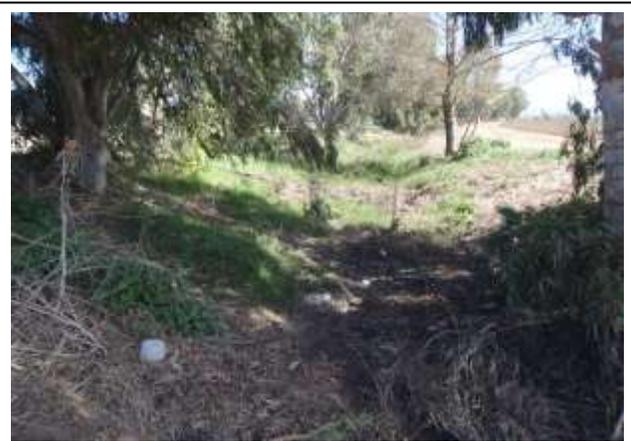
Figure 4-11. Terminus of Tocayo Ditch Sub-drainage

- Ponded or dry conditions were found at all sites at the time of the surveys.
- Bacterial concentrations exceeded thresholds at two of the monitoring sites.
- Human-specific *Bacteroides* was not present at any site.
- Tocayo Ditch is a concrete-lined canal in the upper part of the sub-drainage,

however, the last half-mile is a soft-bottom swale (Figure 4-11). The swale was dry during the time of these surveys and in all previous dry weather monitoring events. Based on these results, it is apparent that runoff in the Tocayo Ditch Sub-drainage does not reach the estuary during dry weather conditions.

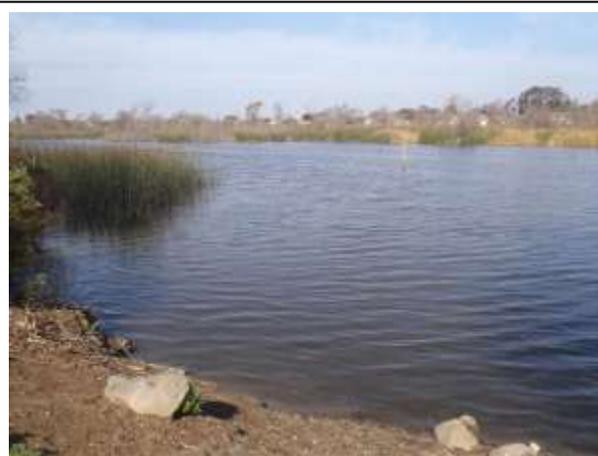
Figure 4-12. Terminus of Mesa Creek Sub-drainage

- The Mesa Creek Sub-drainage is over twice as large as any other sub-drainage in the watershed. The majority of the drainage lies on the eastside of Interstate 5, which crosses under the freeway and discharges to Mesa Creek. The sub-drainage west of Interstate 5 also discharges to Mesa Creek. Flows from the entire sub-drainage pass under Dairy Mart Road and discharge to a series of unlined ponds maintained by earthen berms (Dairy Mart Ponds) (Figure 4-12). Thorough field investigations were unable to reveal any surface water outlet from the ponds to the Tijuana River Estuary (although there is likely groundwater interaction). Based on these results, it is apparent that runoff from the Mesa Creek Sub-drainage does not reach the estuary during dry weather conditions.

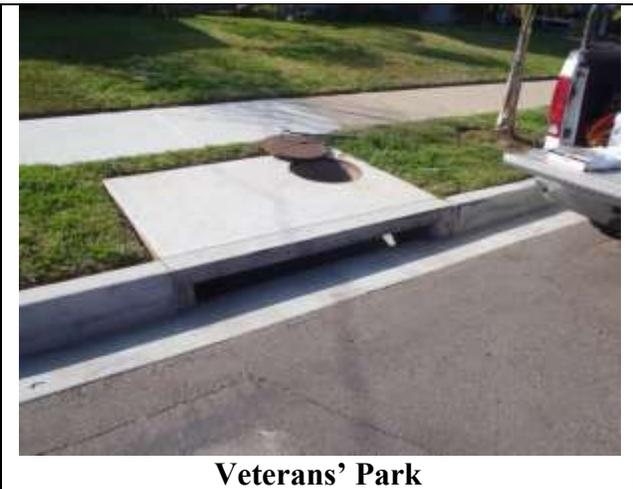
Veterans’ Park is located within the City of Imperial Beach near the corner of Imperial Beach Boulevard and 8th Street (Figure 5-2). Unlike the other sties monitored in the Wet Weather surveys, Veterans’ Park drains a small urban drainage on the U.S. side of the border. Land use in this drainage is made up of low density housing with a small amount of public facility land use (see Section 2). The terminus of this U.S. sub-drainage flows directly to the northern arm of the Tijuana River Estuary via the F-Line outfall. Land use in this drainage is broadly similar to the land use found in the U.S. portion of the Tijuana River Watershed that drains directly to the Tijuana River of the Tijuana River Estuary.

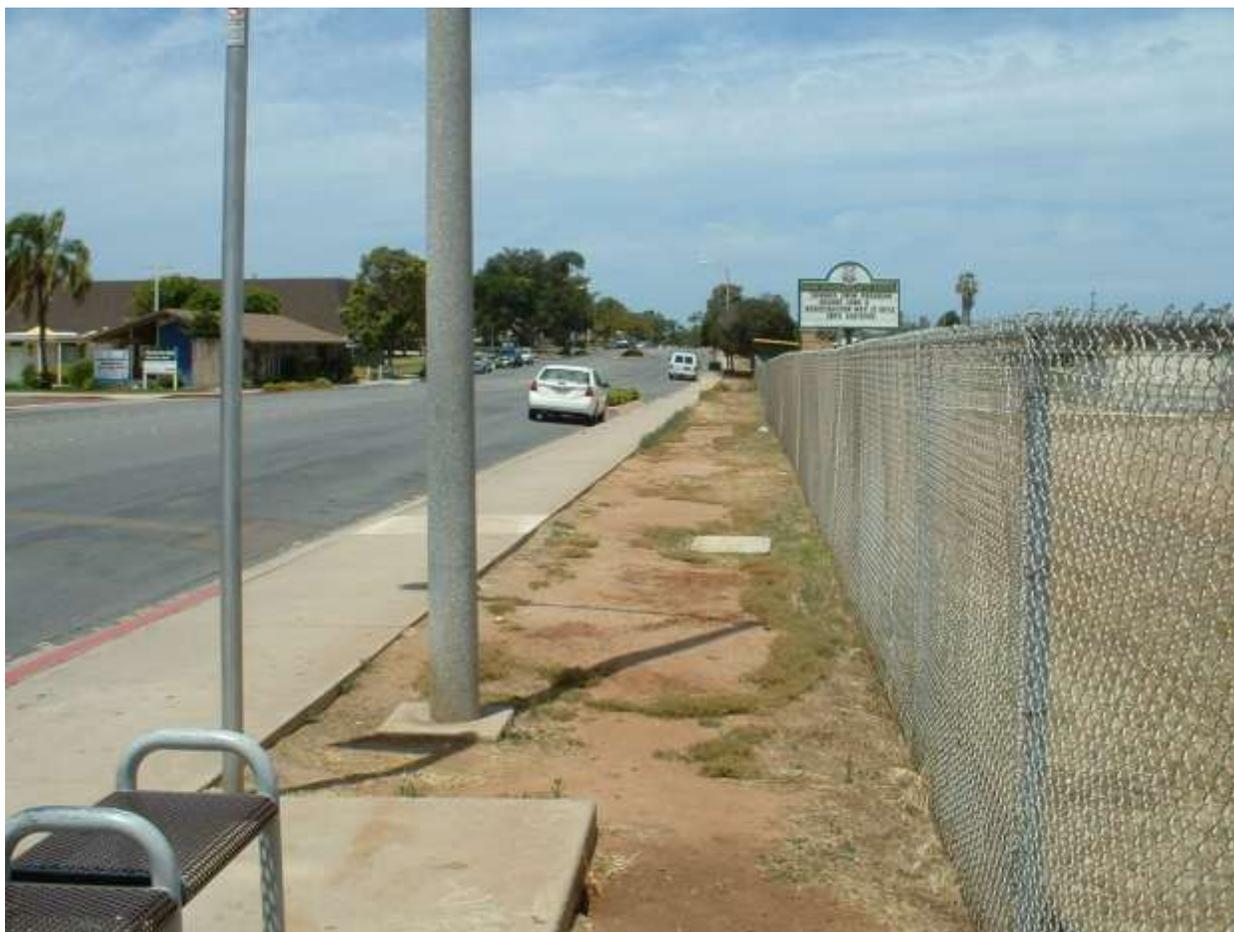
Figure 9-1. Imperial Beach Blvd. Parkway BMPs Project Site

The Site is located along the north side of Imperial Beach Boulevard adjacent to the Mar Vista High School in the City of Imperial Beach. The parkway is approximately 7 feet wide and is currently non-landscaped. The site is shown in Figure 9-1. The proposed improvements are confined to the parkway area and small portions of the sidewalk and curb and gutter. The BMPs are proposed in parkway in areas where there are not existing improvements such as utility vaults, bus stop benches, etc. A vicinity map is provided in Figure 9-2.

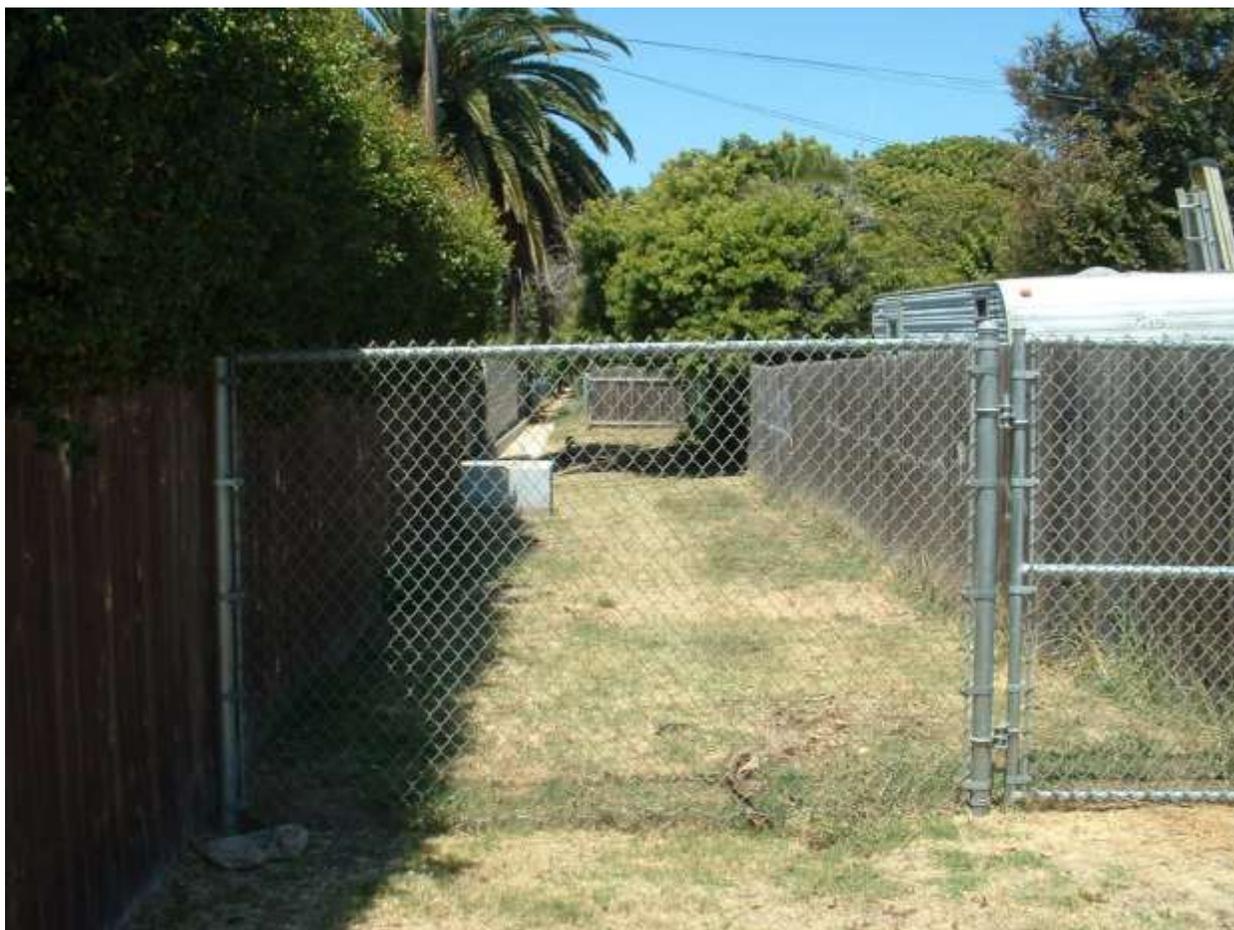
Figure 9-6. Mar Vista Church Easement BMP Project Site

The Site is located within a drainage easement that is located north of the Mar Vista Church (888 5th Street, Imperial Beach) rear parking lot. The Site is accessible via the church parking lot access road and through a locked chain link fence gate. The Site is bound to the east and west by residences, and wooden fences border both the east and west side of the easement. A concrete curb and gutter system is located within the easement and serves as a conveyance for runoff with a slight gradient towards the south and into a raised inlet structure. The existing curb has a height of approximately 1 foot and gutter has a width of approximately 4 feet. In the area where the BMP is proposed the easement widens and varies in width between approximately 12 to 18 feet. The site is shown in Figure 9-6. The proposed improvements are confined the wide portion of the easement north of the chain link fenced and south of wooden fence that is located approximately 115 feet north of chain link fence. A vicinity map is provided in Figure 9-7.

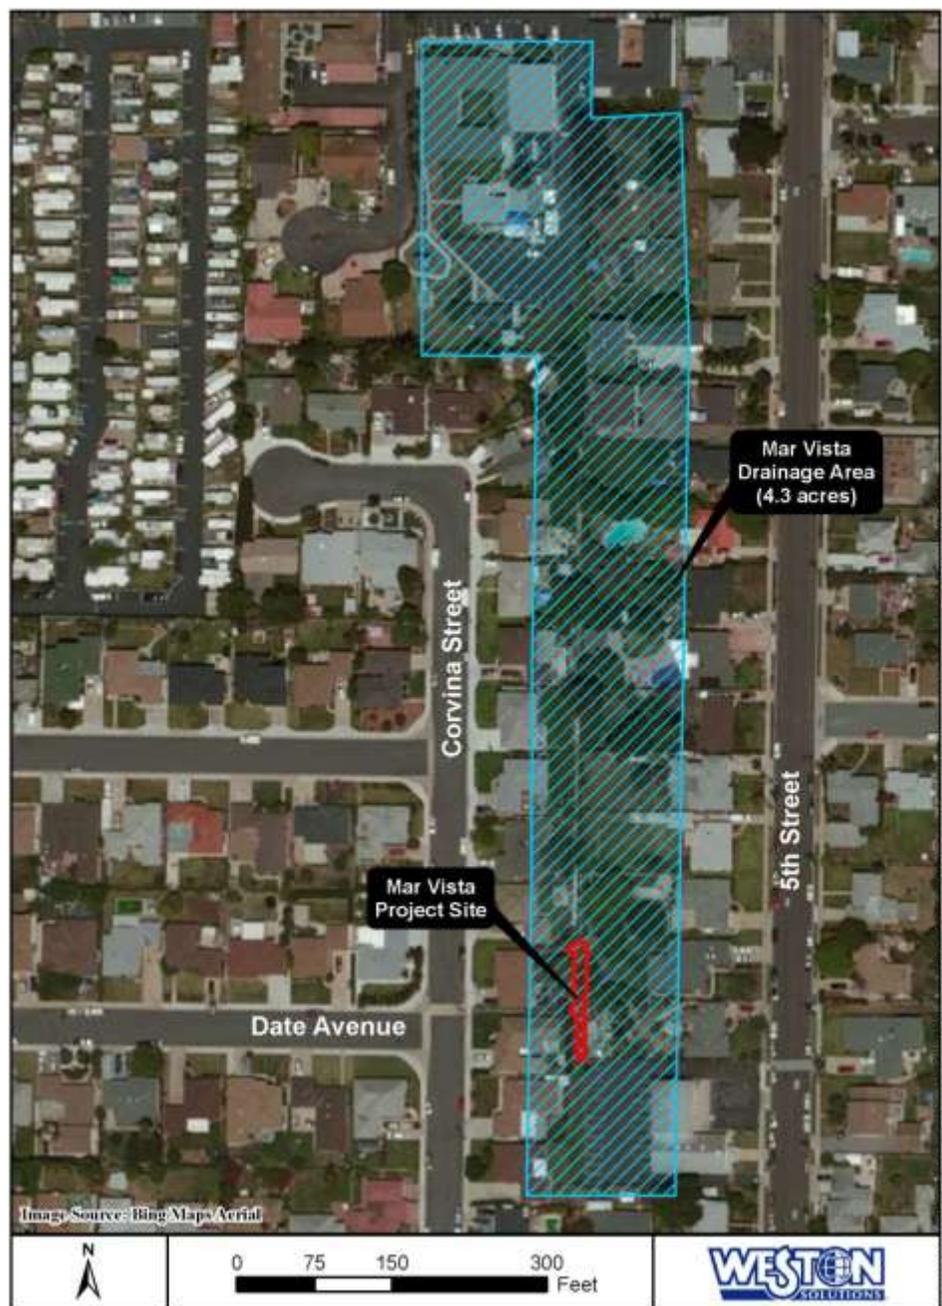
Figure 9-10. Mar Vista Church Drainage Easement Drainage Area

The tributary drainage area to the site is shown on Figure 9-10. The drainage area primarily consists of residential lots and a couple of churches (commercial lots). The overall drainage area measures an area of approximately 4.6 acres. The average, area weighted, impervious percentage used in calculations was 63%. In accordance with guidance found the SUSMP (CSD, 2011) and the County Hydrology Manual (CSD, 2003) water quality calculations were performed for the site. The water quality calculations and results are summarized in Table 9-7. Additional information relating to these calculations is provided in Appendix E-2.

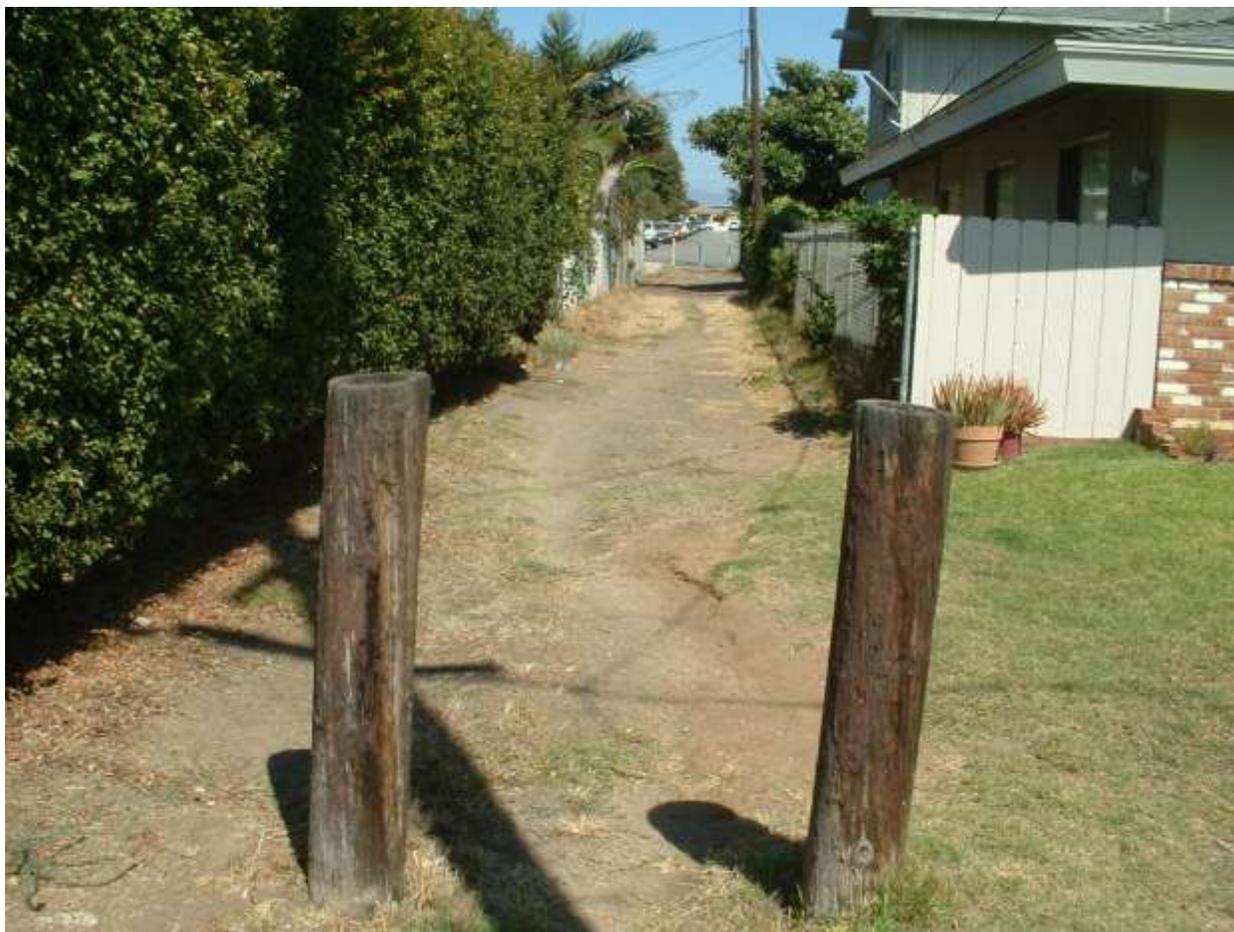
Figure 9-11. Thorn Street Cul-De-Sac Drainage Conveyance Site

The Site is within the City of Imperial Beach utility right-of-way that connects the west end of the Thorn Street cul-de-sac to Fifth Street. The Site is bound to the north and south by residences. The area is currently dirt and sparse vegetation with a swale located near the middle of the right-of-way to convey storm water runoff from Thorn Street to Fifth Street via a concrete sidewalk underdrain that is located adjacent to Fifth Street at the west boundary of the Site. The site is shown in Figure 9-11. The proposed improvements are confined to the area of the right-of-way, which is approximately 10 feet wide and 195 feet in length. A vicinity map is provided in Figure 9-12.

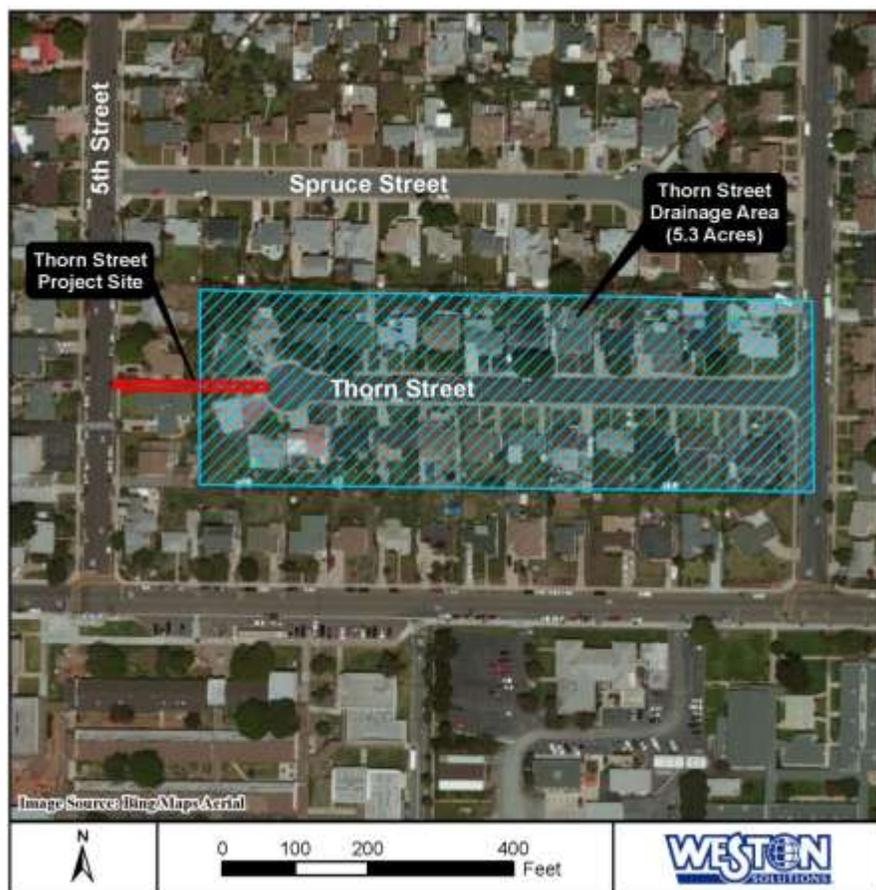
Figure 9-15. Thorn Street Cul-De-Sac Drainage Area

Storm water runoff from Thorn Street collects in the curb and gutter system and travels west onto the Site. The drainage area consists of residential lots located along Thorn Street east of the Site and west of Carolina Street. The tributary drainage area to the site is shown on Figure 9-15. The overall drainage area measures an area of approximately 5.3 acres. The dwelling unity density is approximately 5.0 single-family dwelling per acre and the impervious percentage used in calculations was 40%. In accordance with guidance found the SUSMP (CSD, 2011) and the County Hydrology Manual (CSD, 2003) water quality calculations were performed for the site. The water quality calculations and results are summarized in Table 9-11. Additional information relating to these calculations is provided in Appendix E-2.

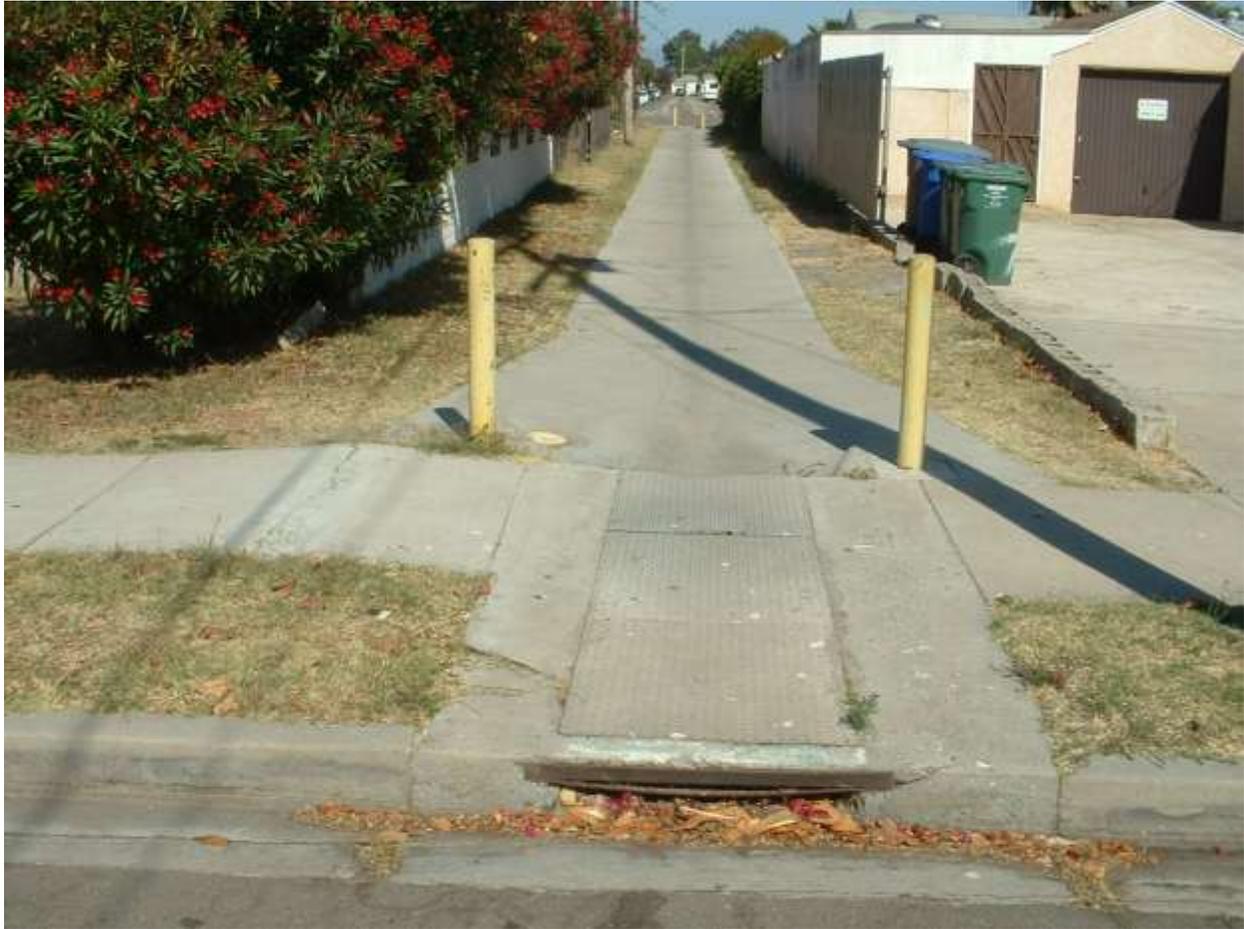
Figure 9-16. Donax Avenue Cul-De-Sac Drainage Conveyance Site

The Site is within the City of Imperial Beach utility right-of-way that connects the west end of the Donax Avenue cul-de-sac to Fifth Street. The Site is bound to the north and south by residences. The area is currently occupied by a concrete drainage swale, with a width of 6 feet,

and sparse grass vegetation on both sides of the swale. At the west boundary of the Site, the concrete swale conveys storm water runoff from the Site to Fifth Street via a steel plate cover sidewalk under located adjacent to Fifth Street. The site is shown in Figure 9-16. The proposed improvements are confined to the area of the right-of-way, which is approximately 10 feet wide and 192 feet in length. A vicinity map is provided in Figure 9-17.

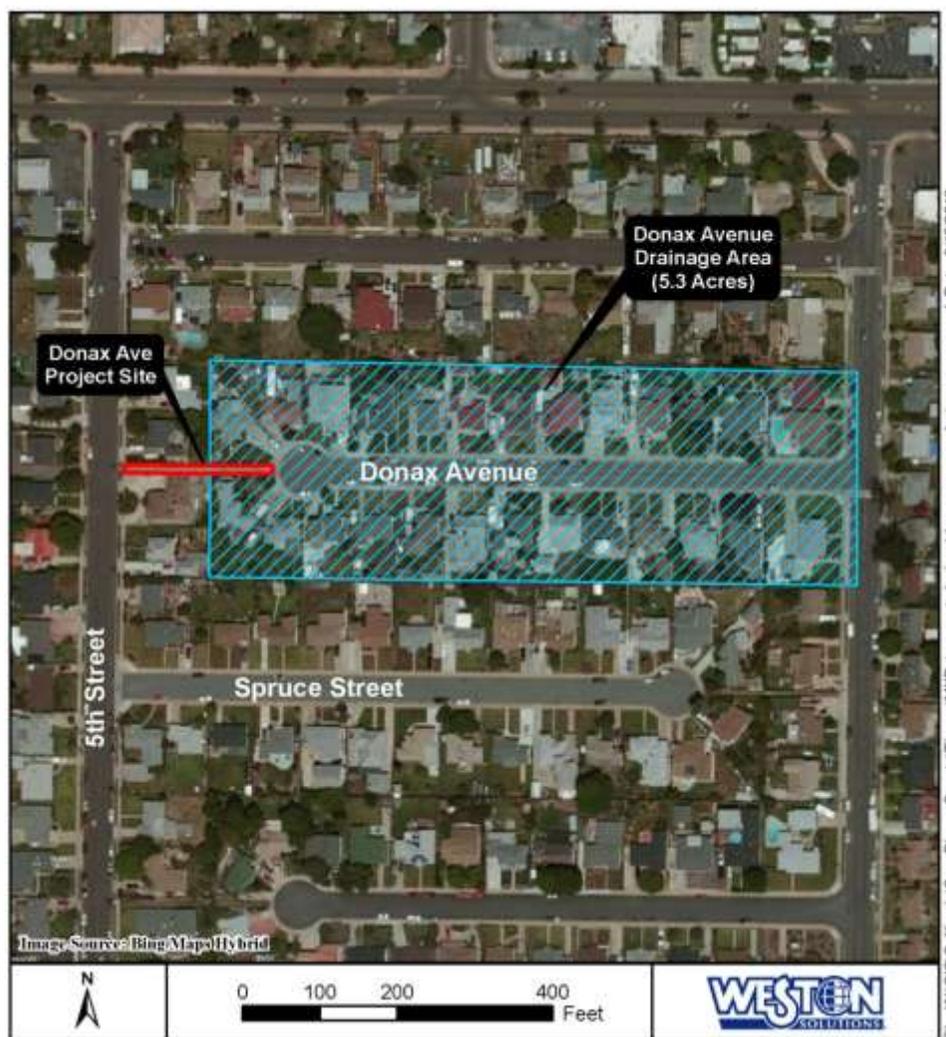
Figure 9-20. Donax Avenue Cul-De-Sac Drainage Area

Storm water runoff from Donax Avenue collects in the curb and gutter system and travels west onto the Site. The drainage area consists of residential lots located along Donax Avenue east of the Site and west of Carolina Street. The tributary drainage area to the site is shown on Figure 9-20. The overall drainage area measures an area of approximately 5.3 acres. The dwelling unity density is approximately 5.0 single-family dwelling per acre, and the impervious percentage used in calculations was 40%. In accordance with guidance found the SUSMP (CSD, 2011) and the County Hydrology Manual (CSD, 2003) water quality calculations were performed for the site. The water quality calculations and results are summarized in Table 9-15. Additional information relating to these calculations is provided in Appendix E-2.

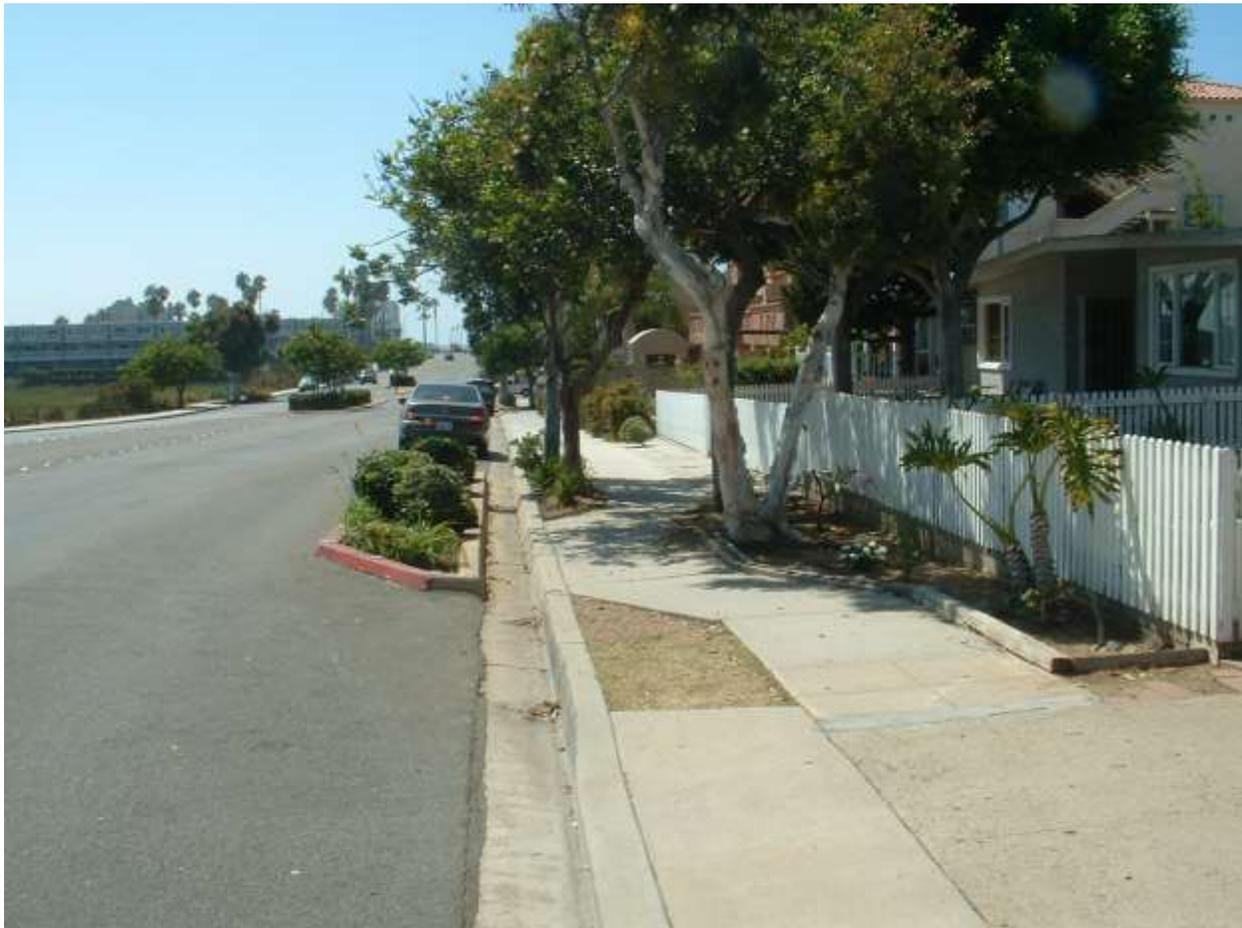
Figure 9-21. Imperial Beach Boulevard and Second Street Intersection

The Site is located within the Imperial Beach Boulevard right-of-way between Seacoast Drive and Connecticut Street. The Site is bound to the north and south by residences, commercial properties, and Mar Vista High School. A portion of the site is shown in Figure 9-21. Note the traffic calming shown in the figure (conventionally landscaped planter), which are typical along the roadway near intersections. The proposed improvements are confined to the areas where existing traffic calming planters protrude out from the curb and gutter, mainly in the areas of intersections. A vicinity map is provided in Figure 9-22.

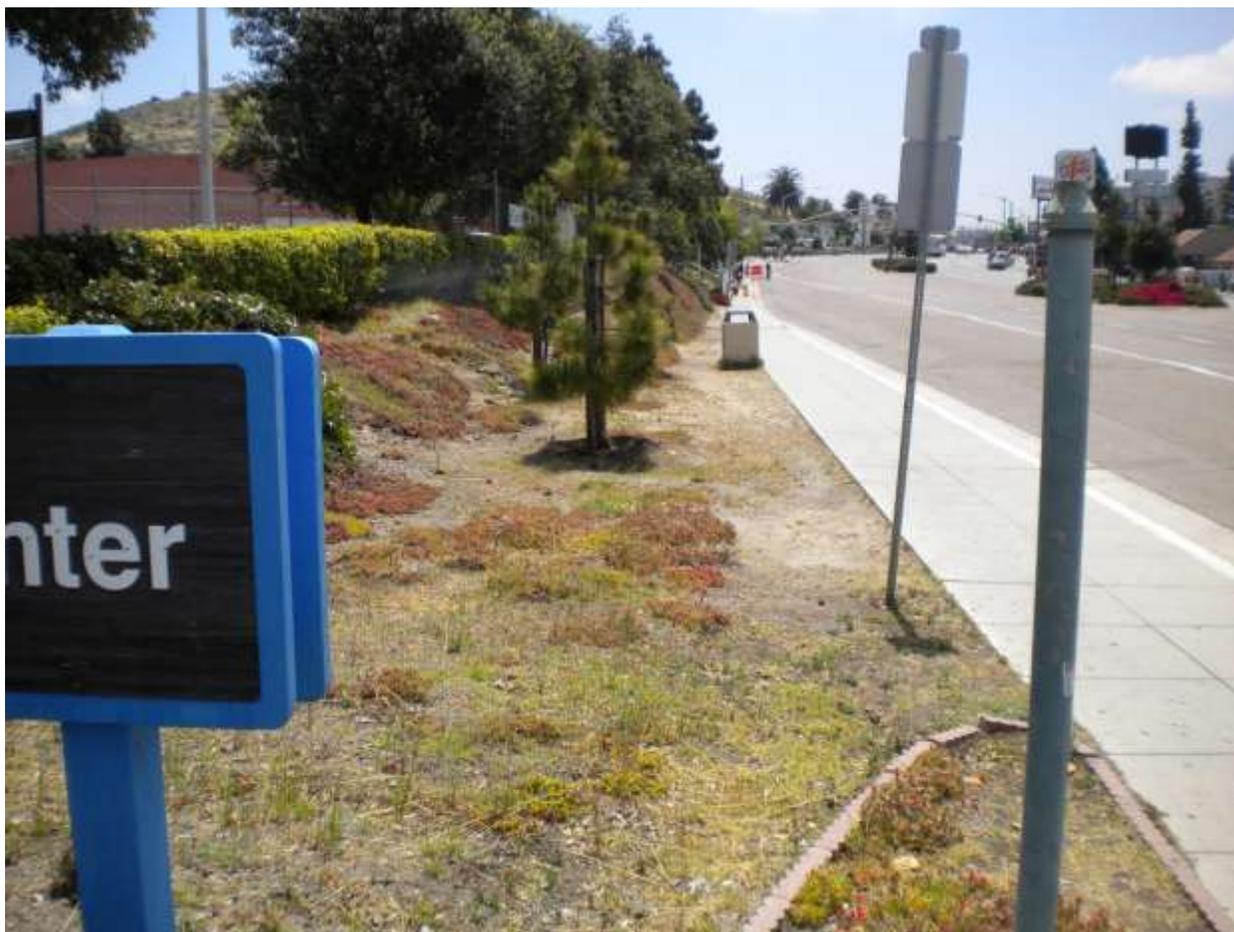
Figure 9-25. East San Ysidro Boulevard Site

The Site is located within the City of San Diego right-of-way for East San Ysidro Boulevard. More specially, the Site is located within the parkway area along the north side of the roadway in front of the San Ysidro Community Center having the address 663 East San Ysidro Boulevard. The area is currently occupied by a conventional landscaping. The site is shown in Figure 9-25. The proposed improvements are confined to the area of the right-of-way, which is approximately 12 feet wide and 140 feet in length. A vicinity map is provided in Figure 9-26.
